DEPARTMENT OF TRANSPORTATION

Quality Assurance and Source Inspection

Contract #: 04-0120F4Cty: SF/ALA Rte: 80 PM: 13.2/13.9File #: 69.28**WELDING INSPECTION REPORT****Resident Engineer:**Pursell, Gary**Address:** 333 Burma Road**City:** Oakland, CA 94607**Report No:** WIR-011804**Date Inspected:** 04-Feb-2010**Project Name:** SAS Superstructure**OSM Arrival Time:** 700**Prime Contractor:** American Bridge/Fluor Enterprises, a JV**OSM Departure Time:** 1900**Contractor:** Zhenhua Port Machinery Company, Ltd (ZPMC), Changxing Island **Location:** Shanghai, China**CWI Name:** Li Yan Hua.**CWI Present:** Yes No**Inspected CWI report:** Yes No N/A**Rod Oven in Use:** Yes No N/A**Electrode to specification:** Yes No N/A**Weld Procedures Followed:** Yes No N/A**Qualified Welders:** Yes No N/A**Verified Joint Fit-up:** Yes No N/A**Approved Drawings:** Yes No N/A**Approved WPS:** Yes No N/A**Delayed / Cancelled:** Yes No N/A**Bridge No:** 34-0006**Component:** OBG**Summary of Items Observed:**

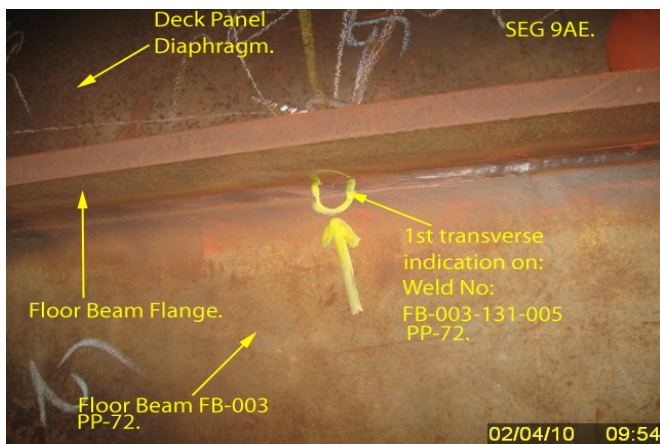
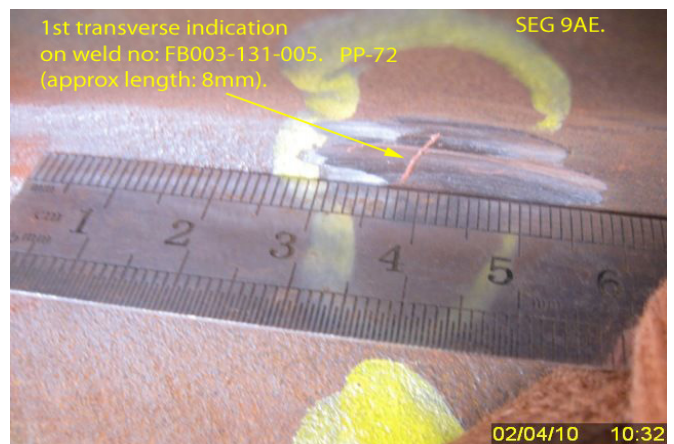
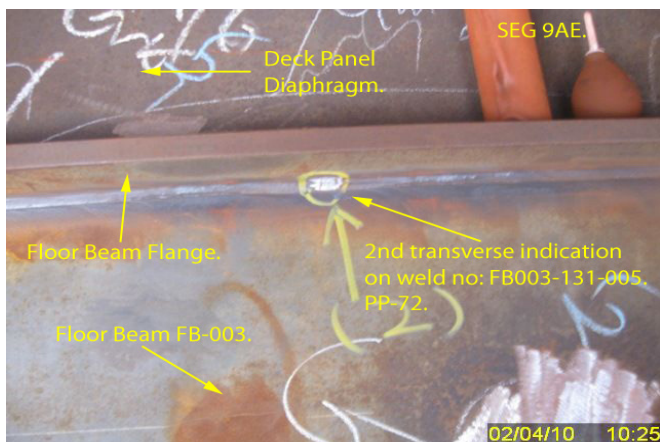
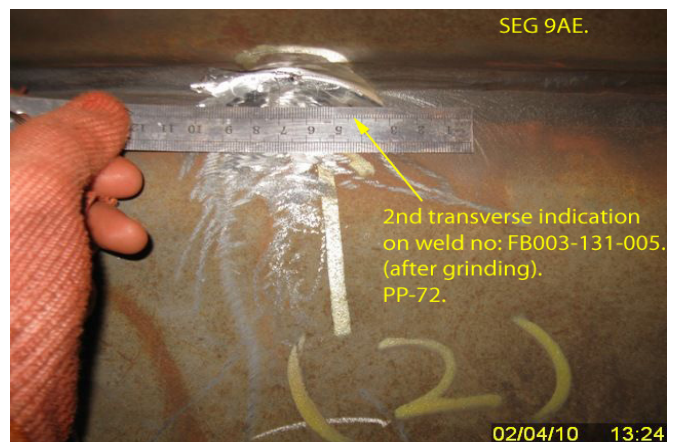
This QA Inspector visually discovered two transverse linear indications on Floor Beam Flange to Floor Beam fillet weld identified as PP72-SSD19-004. This was then confirmed by performing Magnetic Particle Testing (MT). One of the indications was observed as approximately 8mm length and the other was observed around 15mm length. ZPMC QA representative Mr. Zhong Wei & ABF representative Mr. Peter Shaw, were verbally notified about this issue & that an incident report would be generated. These welds were previously tested 25% by ZPMC Quality Control (QC) personnel. This QA Inspector has generated MT report for this date.

For details, refer attached images.
